**CENTRAL LIBRARY**

Investigation Report

Central Library Fire  
Los Angeles, California  
April 29, 1986

Michael S. Isner

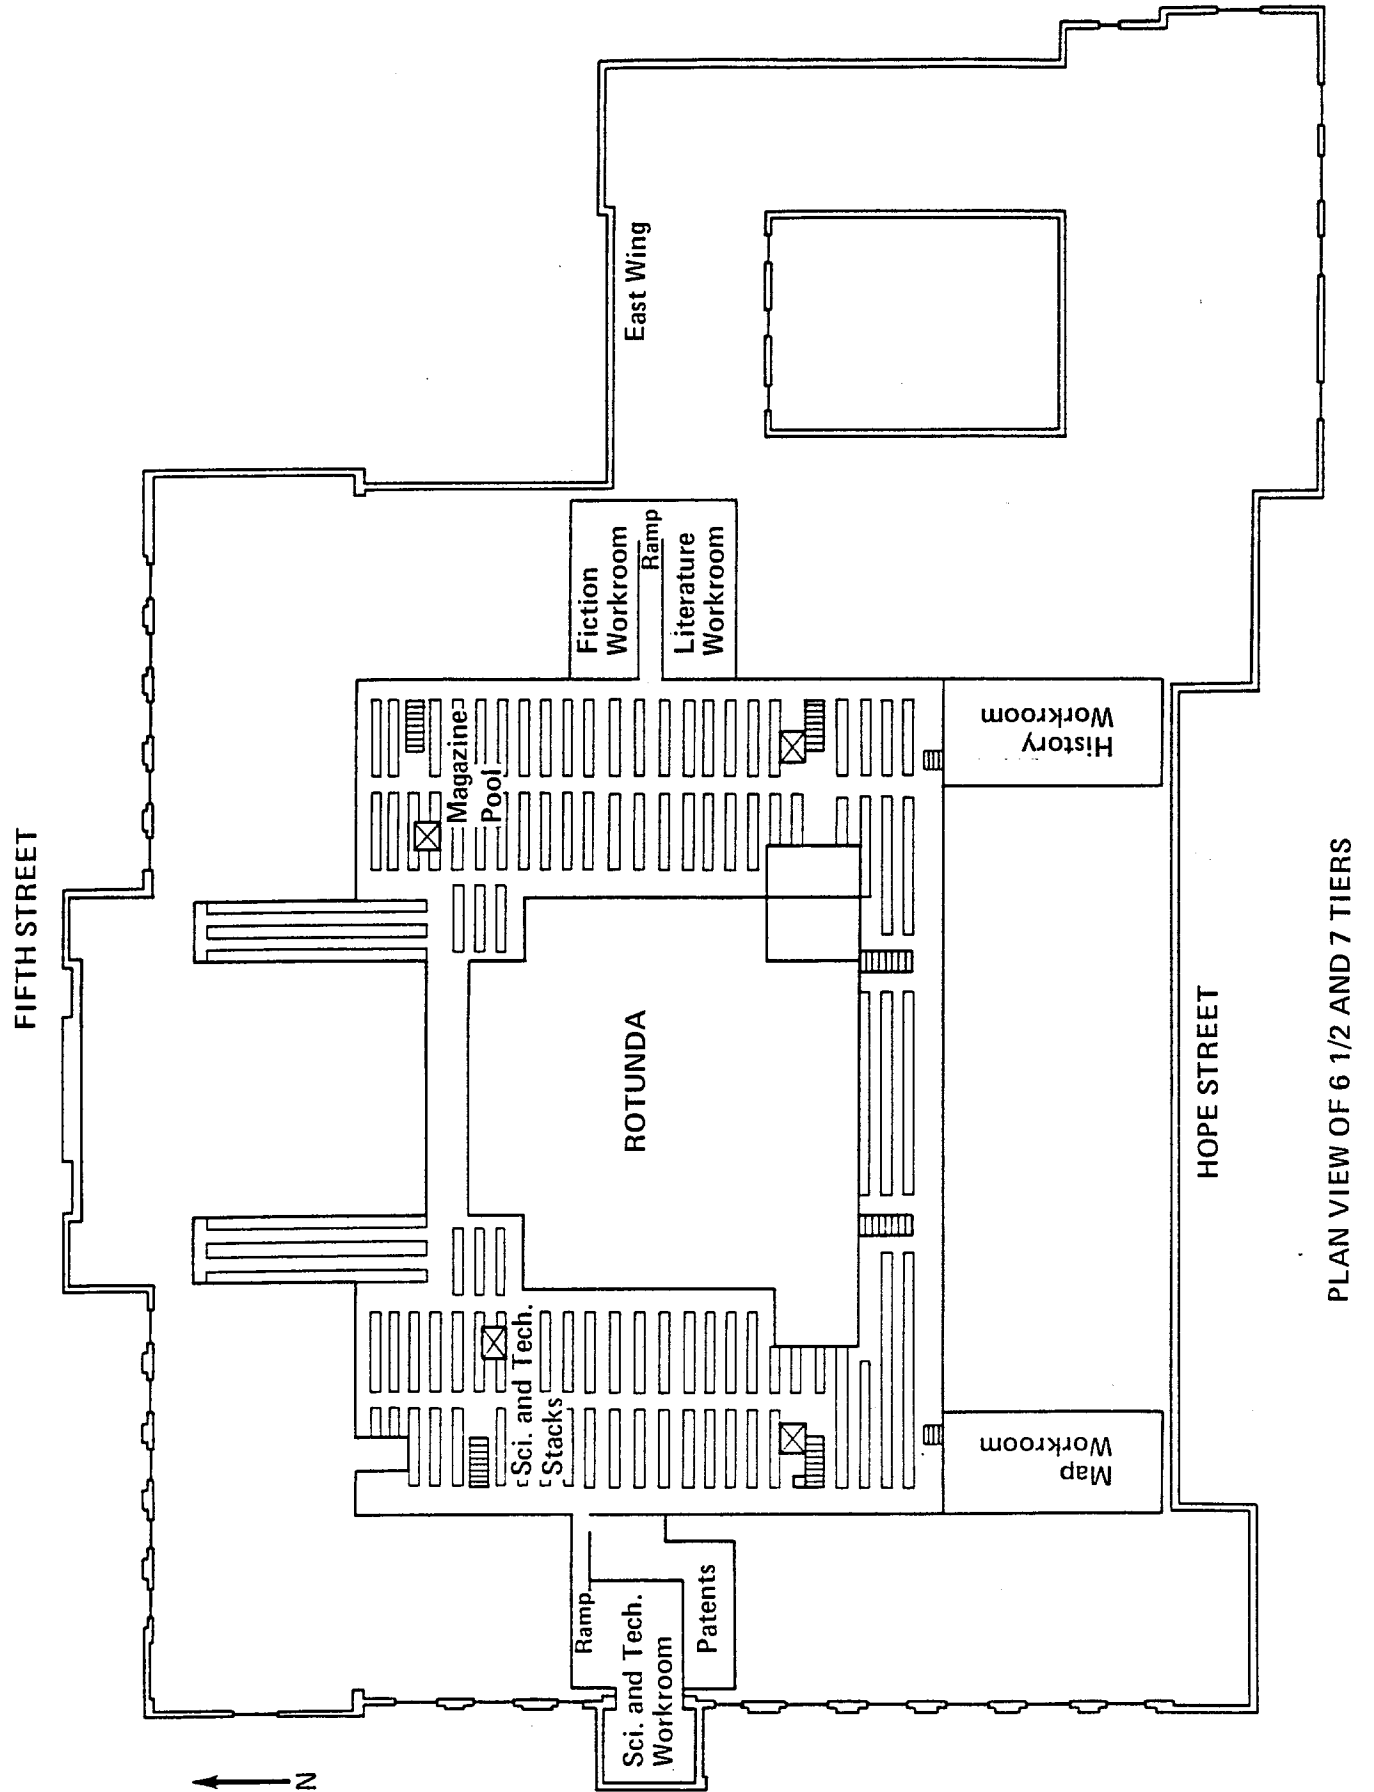
Figure 2

On the 5th tier of the northeast stack, the fire spread along the shelves on both sides of the aisle in which the fire started. The fire extended about 10 feet horizontally in both directions from the suspected point(s) of fire origin. The fire spread into adjacent aisles and up into the tier level above (see Figure 5). Only a small percentage of books were involved on the 5th tier level. Once in the 6th tier, nearly one-third of the books were burned and the others received some smoke and heat damage.

PLAN VIEW OF 6 1/2 AND 7 TIERS

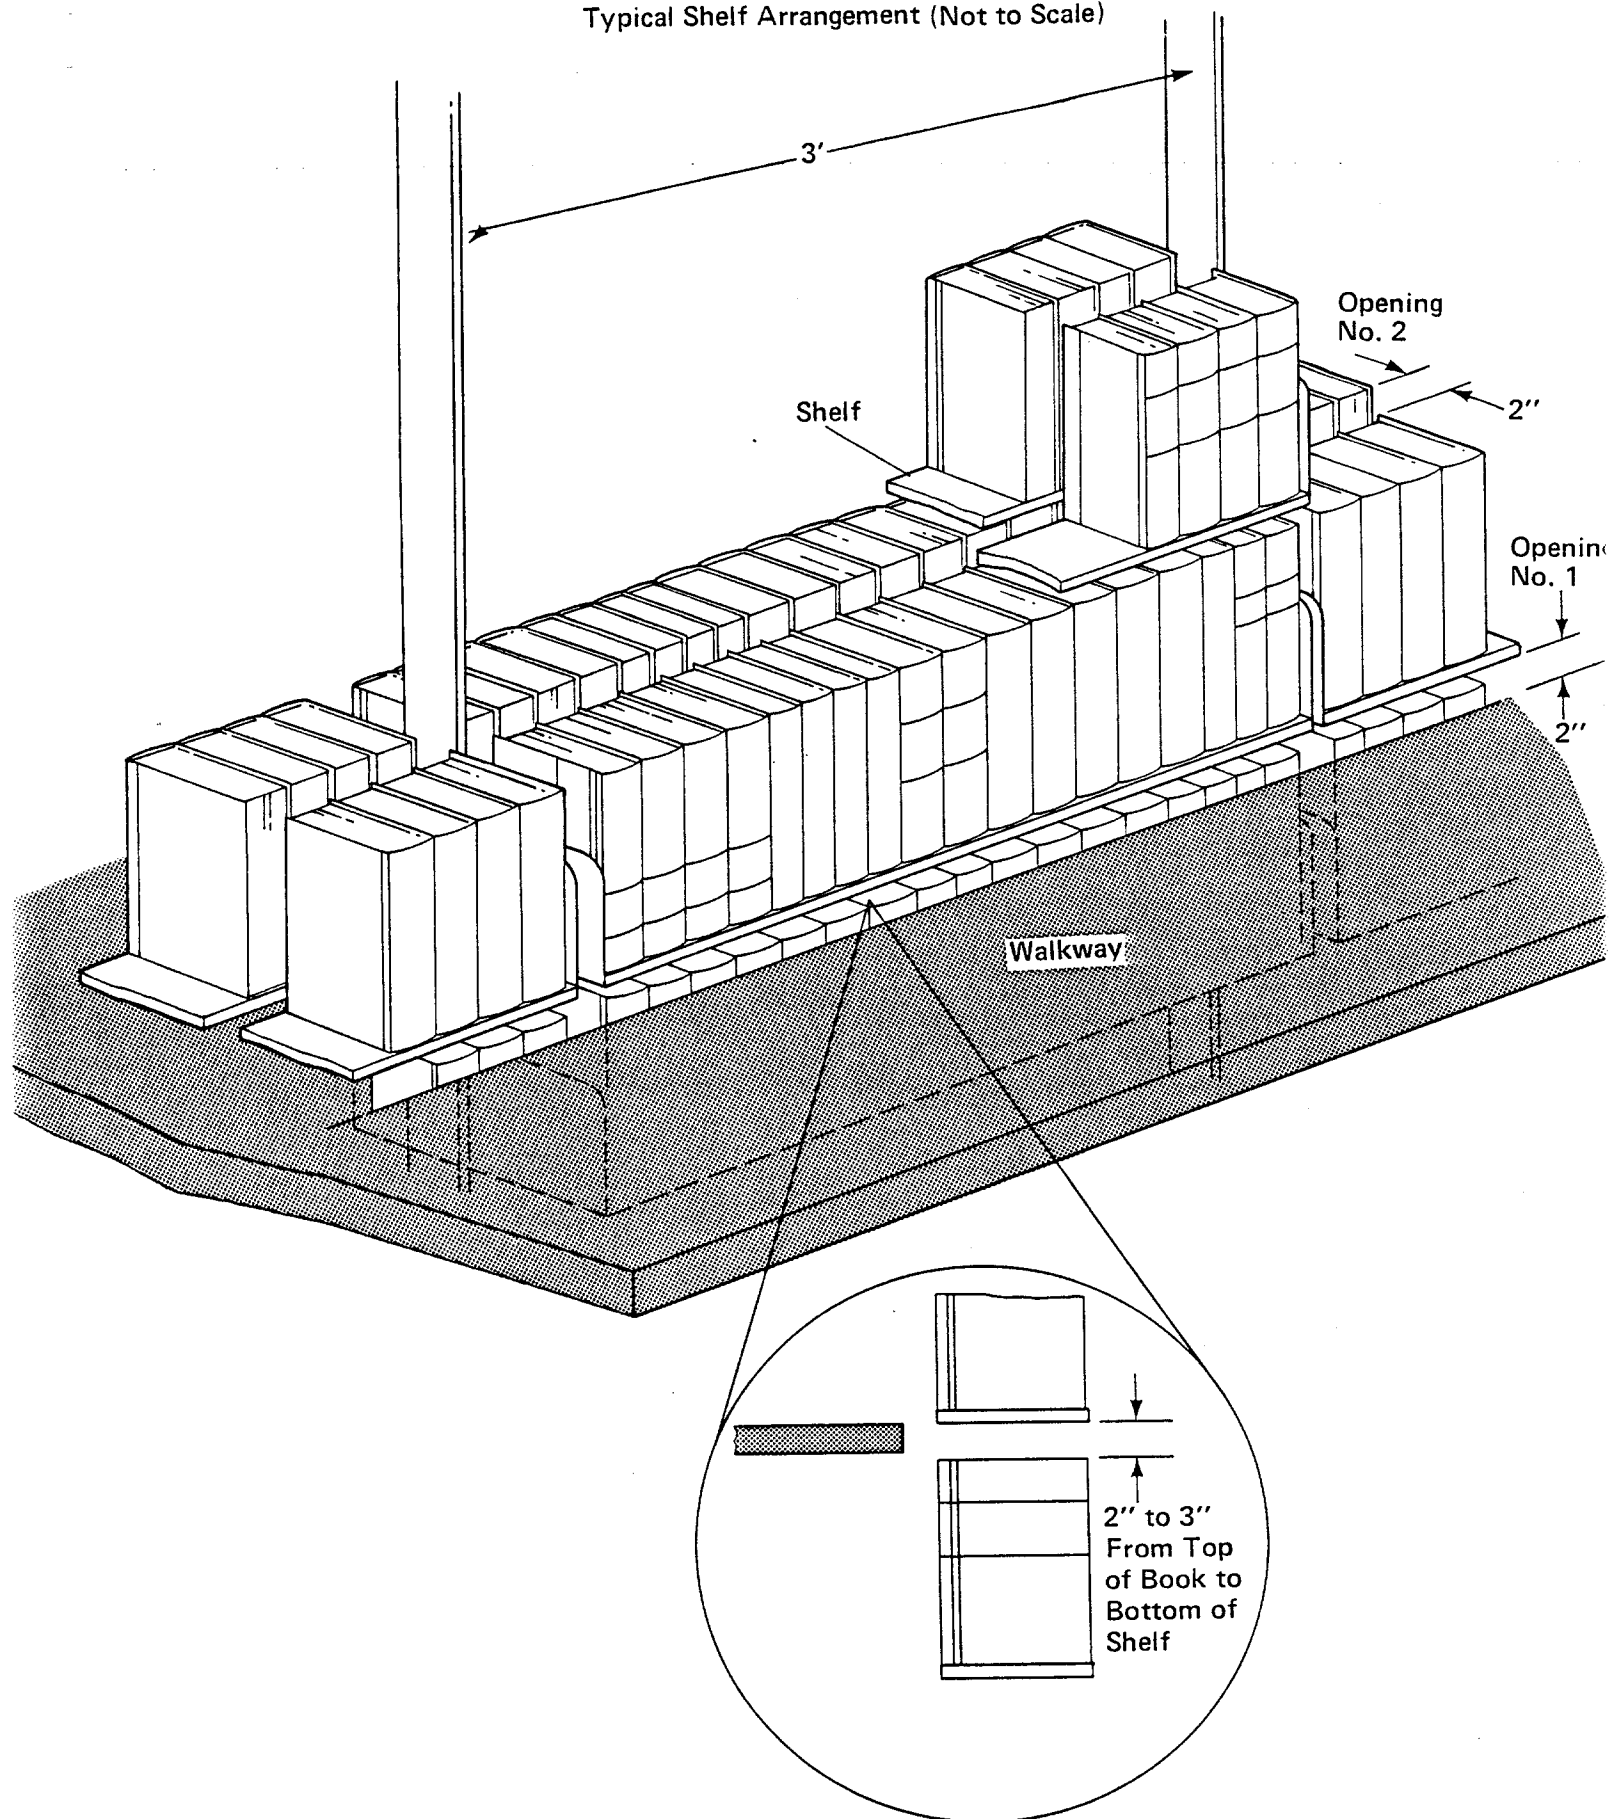
Figure 3

Typical Shelf Arrangement (Not to Scale)

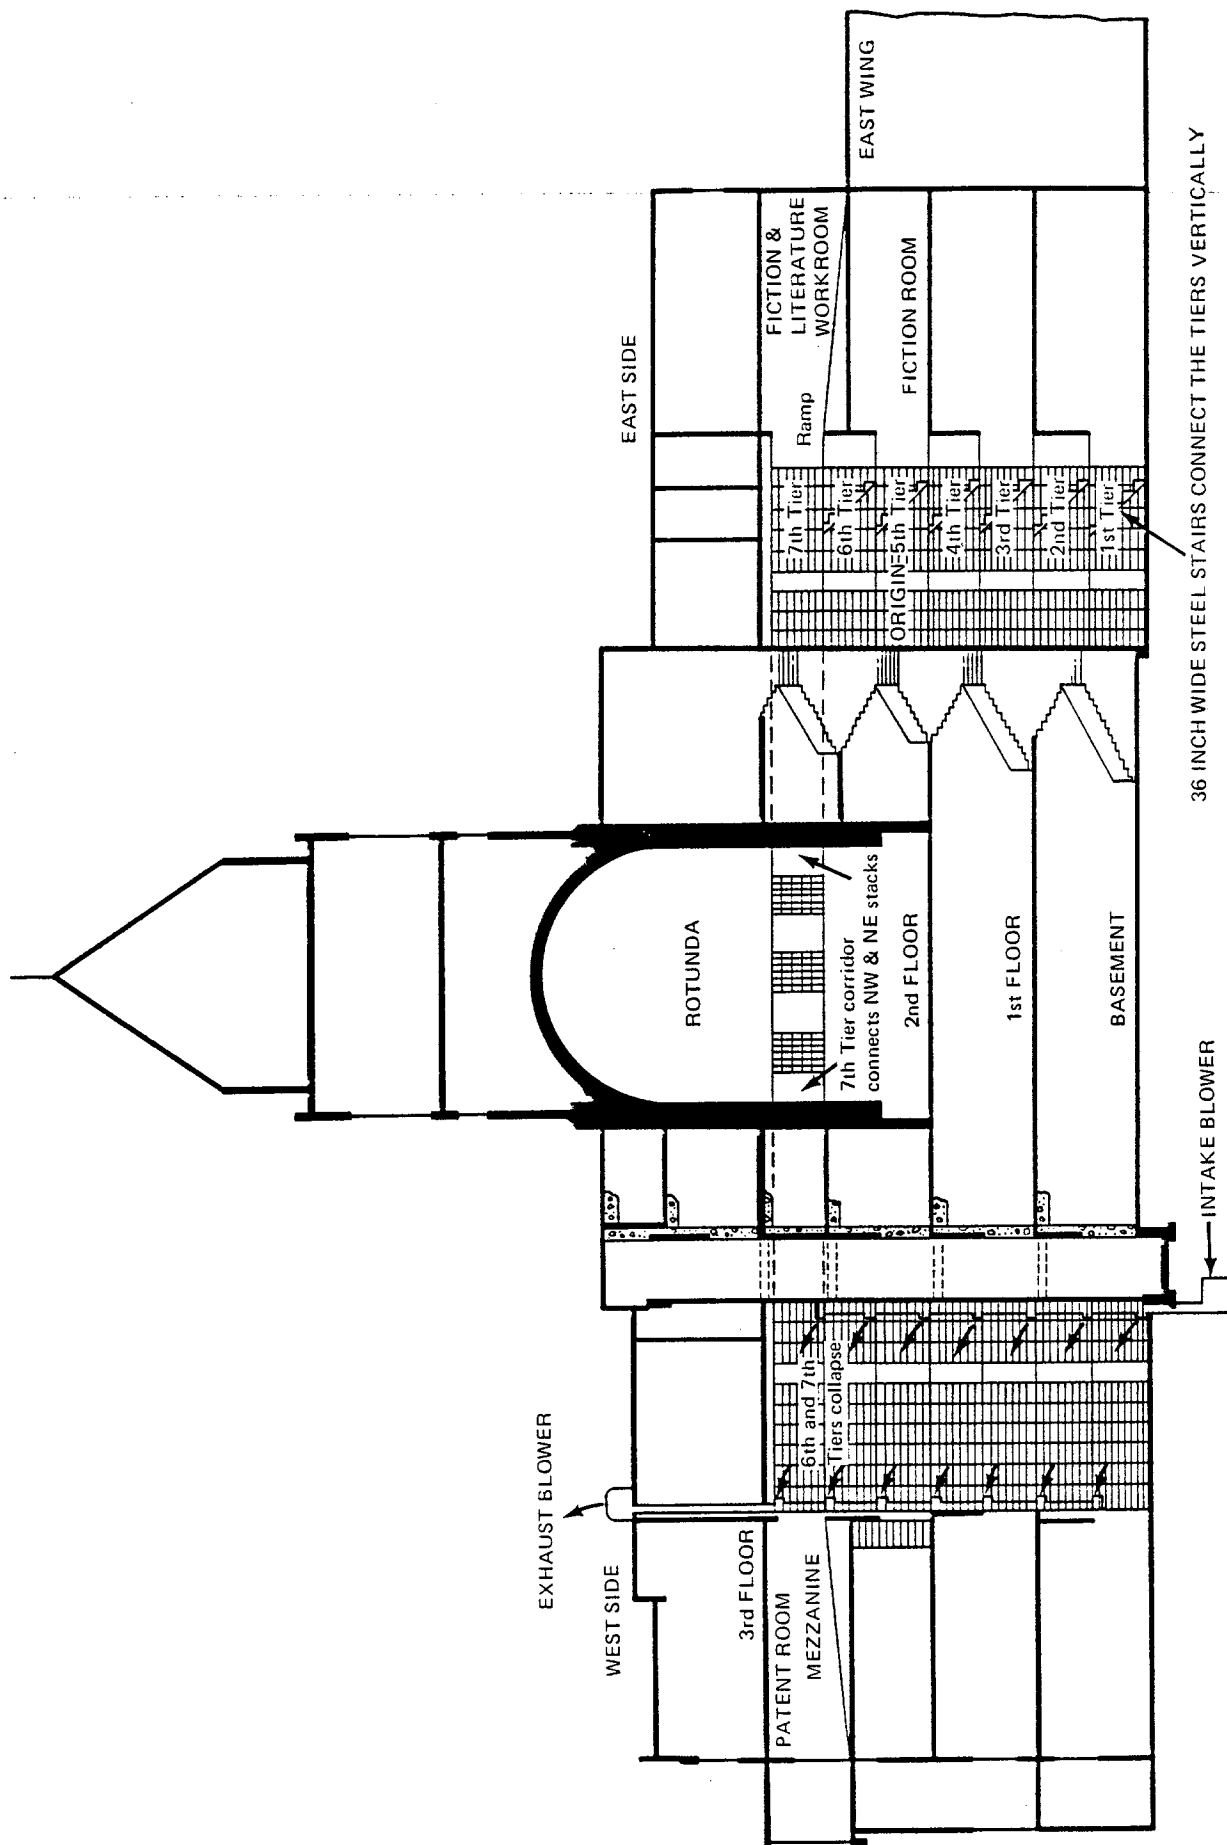
Figure 4

Stairways in the stack area are 36 inches wide and have no door protecting the openings at floor levels. These stairways do not have landings between tier levels and are vertically in-line (see Figure 4). A person traveling between tier levels must leave the stairway at any tier and use an aisle to reach the entrance of the stairway to the next tier level.

A mechanical air-handling system enhances the natural air circulation within the stack levels. Makeup air is drawn in at the base of the stacks and is discharged at each tier level. A duct on the opposite side of the tiers collects air from the stack and then the air is discharged at roof level (see Figure 4). Openings between the bookshelves and walkways (opening #1, see Figure 3), between the backs of bookshelves (opening #2, see Figure 3), and around the entire perimeter of the stack area also contribute to air circulation within the book stacks. Apparently, circulating air would contribute to the heating of the stacks and would help preserve books and reduce mildew in the non-air-conditioned building.

Having identified the location of the detector activations from the main alarm panel, the E-3 crew entered the NE stack in the basement and climbed the 36-inch wide open stairs to the 5th tier where they left the stack to tie into a hose station located in a stairway leading to the second floor (see Figure 4). The crew reentered the stack at the 5th tier level, advanced their hose

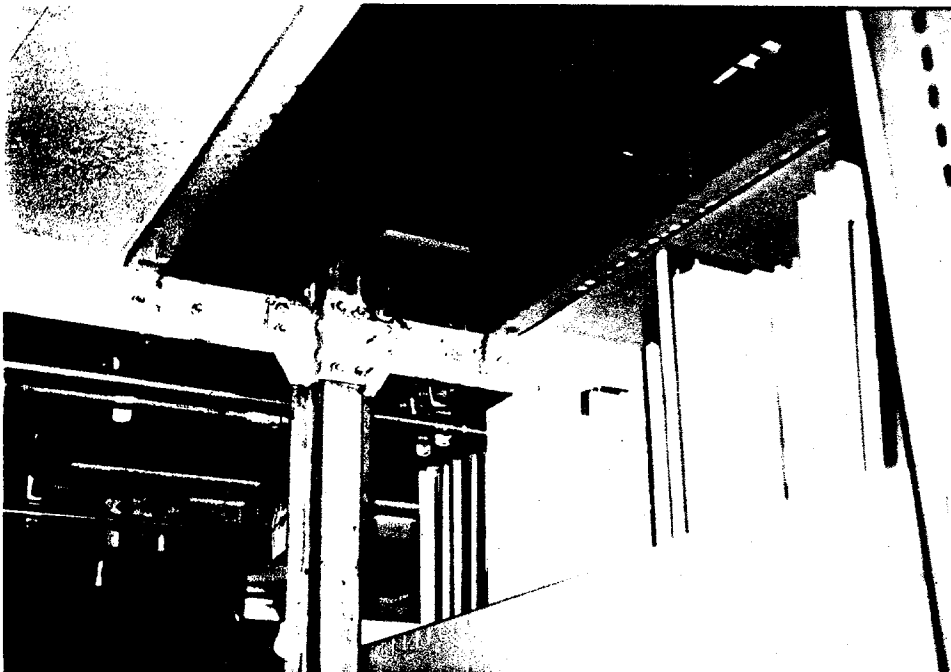
Photo 2  
Framework which Supports Walkways and  
Bookshelves in Stack Area. Credit: NFPA
